## MEMORANDUM

Date: March 19, 2018  
To: Board of Directors  
From: Mark Martin, General Manager  
Subject: Update on Sewer Lateral Issue – Lot 1709

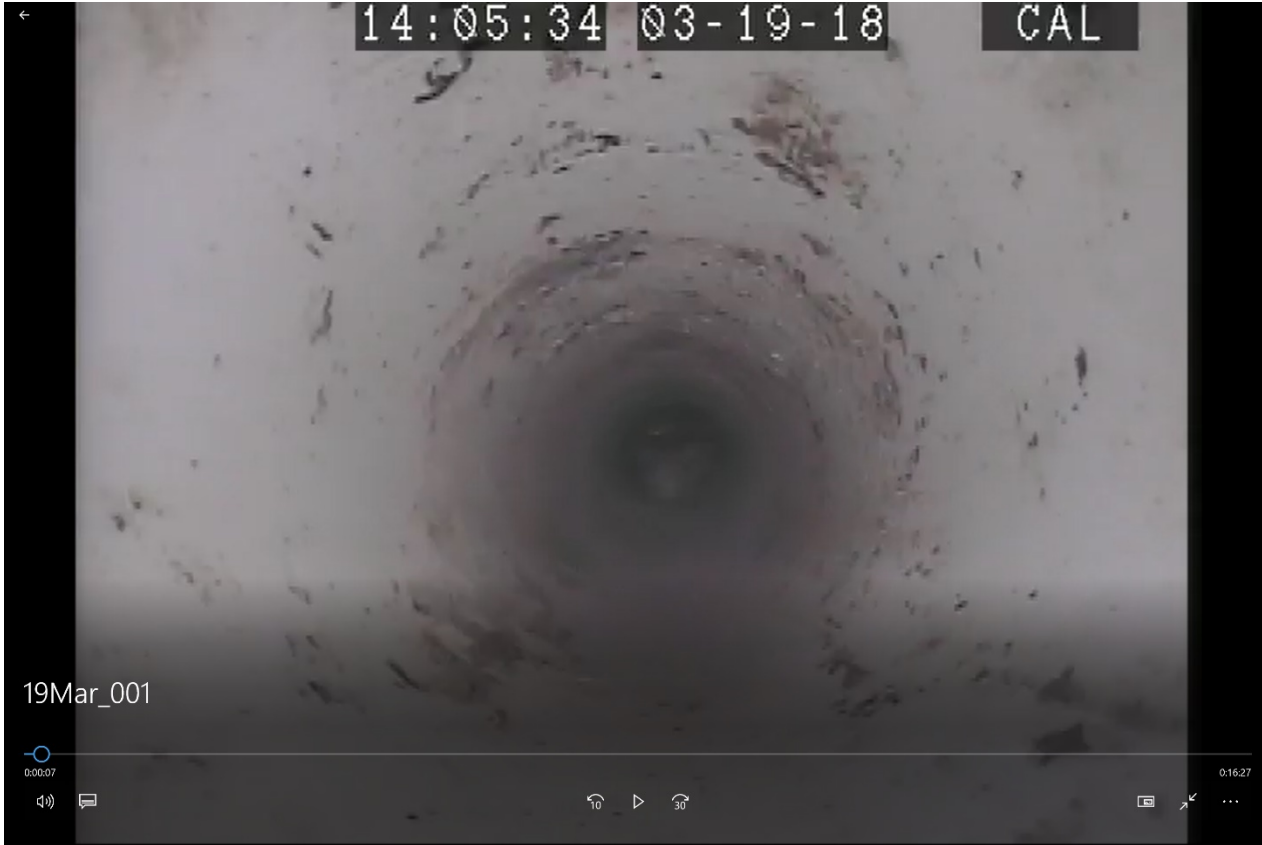
Capture #1: Scope being lowered down shaft of cleanout (note absence of effluent along pipe)

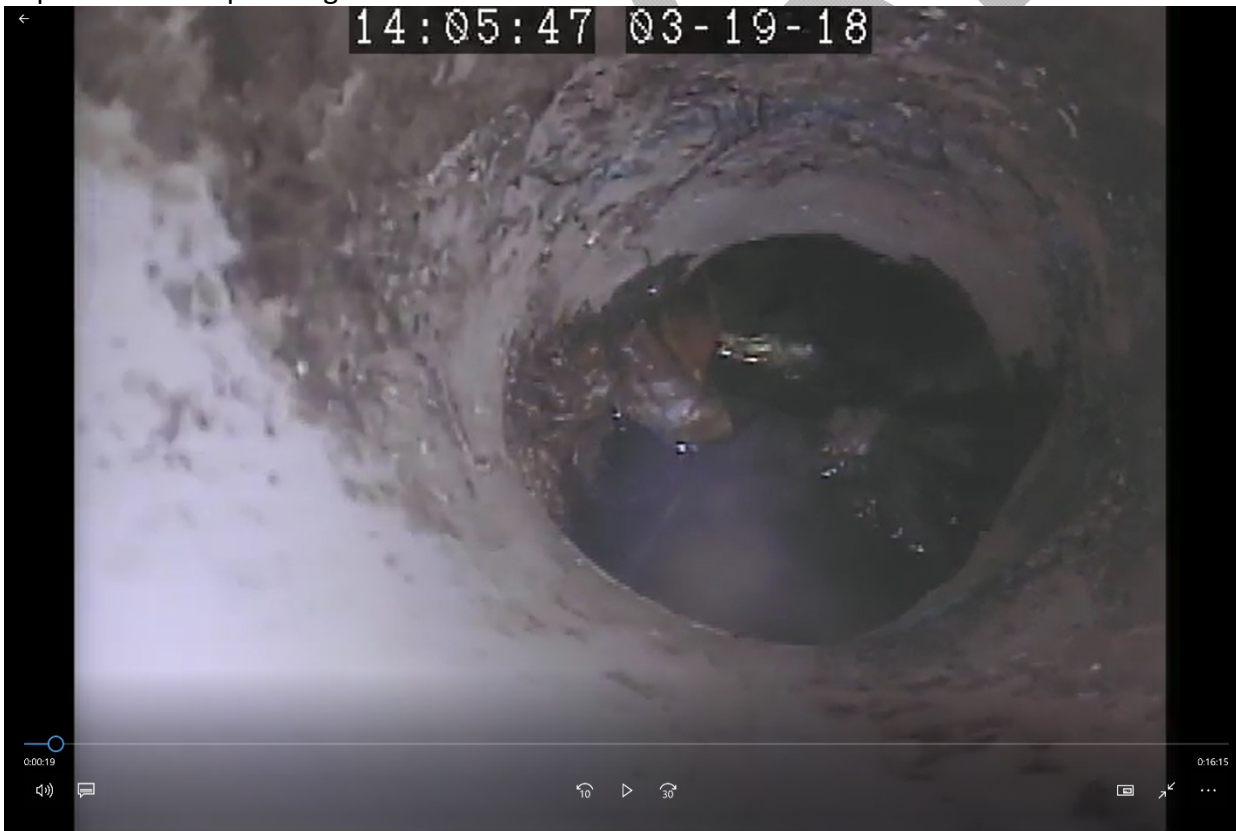
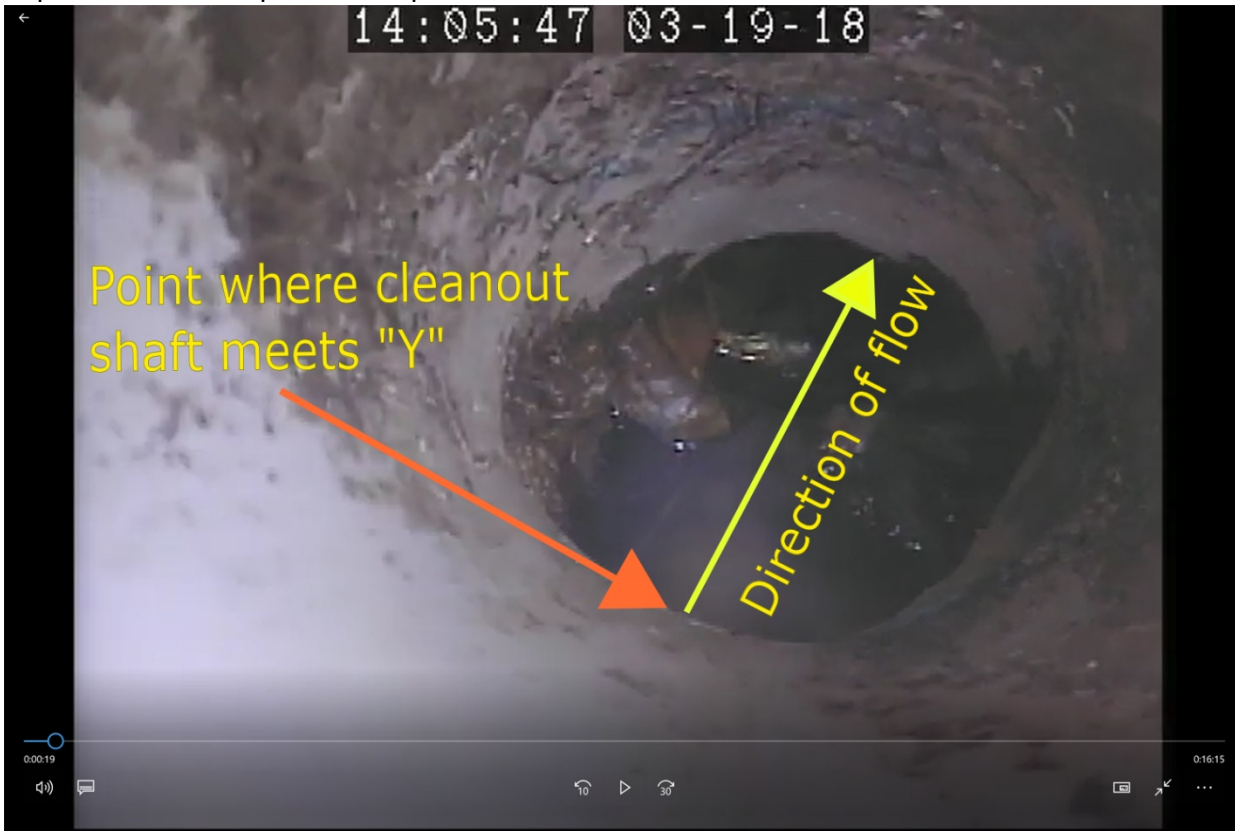
The scope traveled down the shaft of the cleanout and upon approaching the “Y” of the cleanout structure evidenced an apparent breakage at the point the horizontal portion of the line carries effluent to the main. The breakage was immediate to the “Y” indicating the area of the break is within the cleanout structure and therefore is the responsibility of the homeowner for maintenance and repair. (See Attachment D screenshots, particularly 4B, 5, and 6). Staff continued to scope the remainder of the line which appeared to be in good shape including revealing what appears to be a successfully performing joint that is likely where the flexible coupling from the District’s sewer stub is located. After reviewing the video a number of times, it is my conclusion the break is within the area of responsibility of the homeowner to repair.

Capture #4A: Scope being lowered down shaft of cleanout at cleanout "Y"

Capture #4B: Same photo of Capture 4A with annotation – **Area of failure**

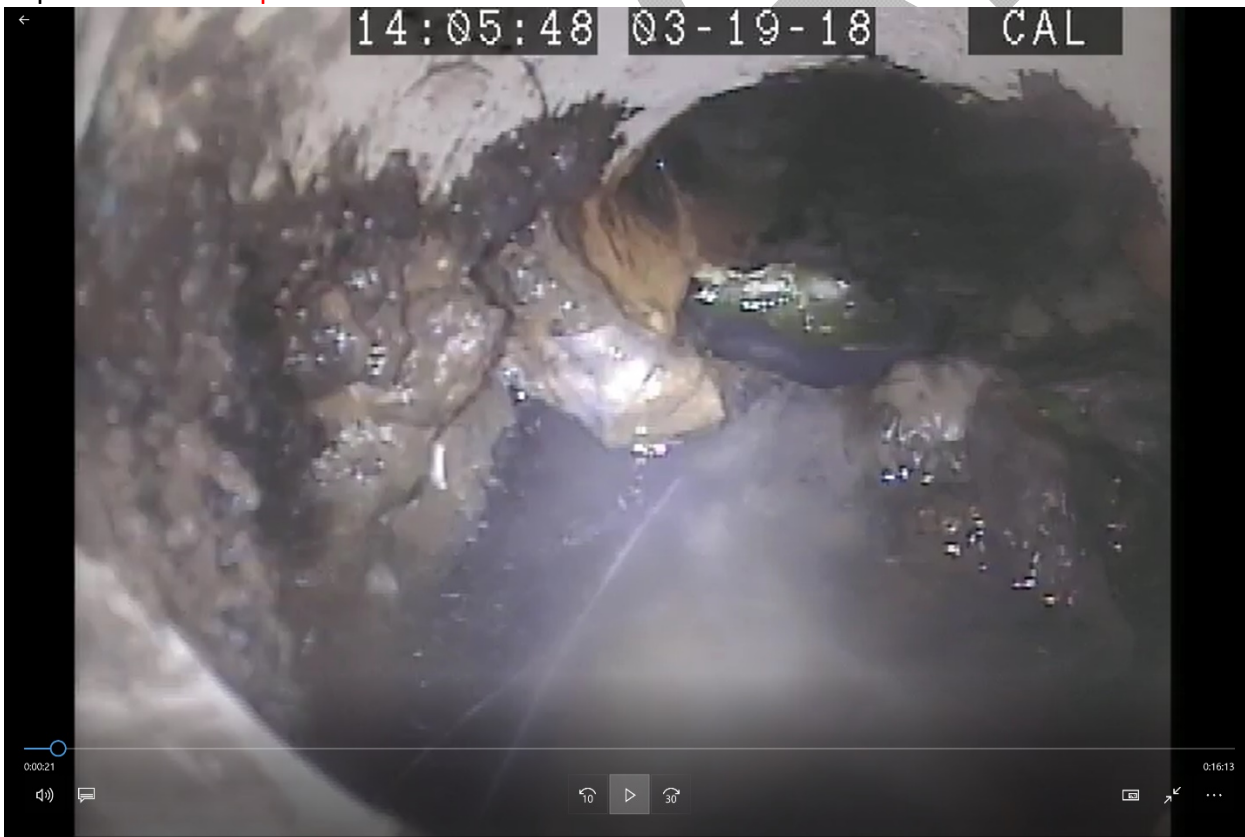
Capture #5: **Close-up of area of failure**

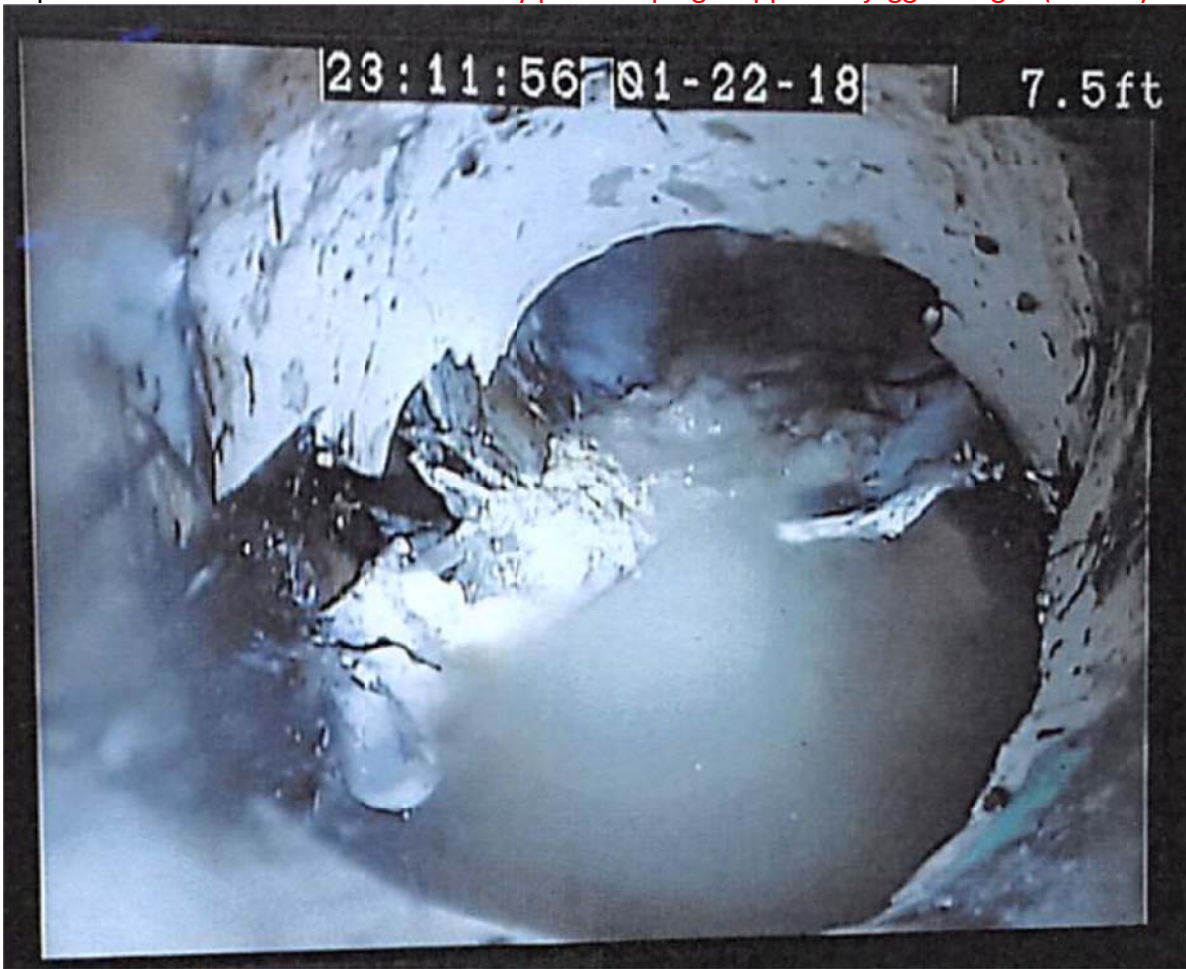
Capture #6: Shot of failure area taken by prior scoping – apparent jagged edges (January 22, 2018)

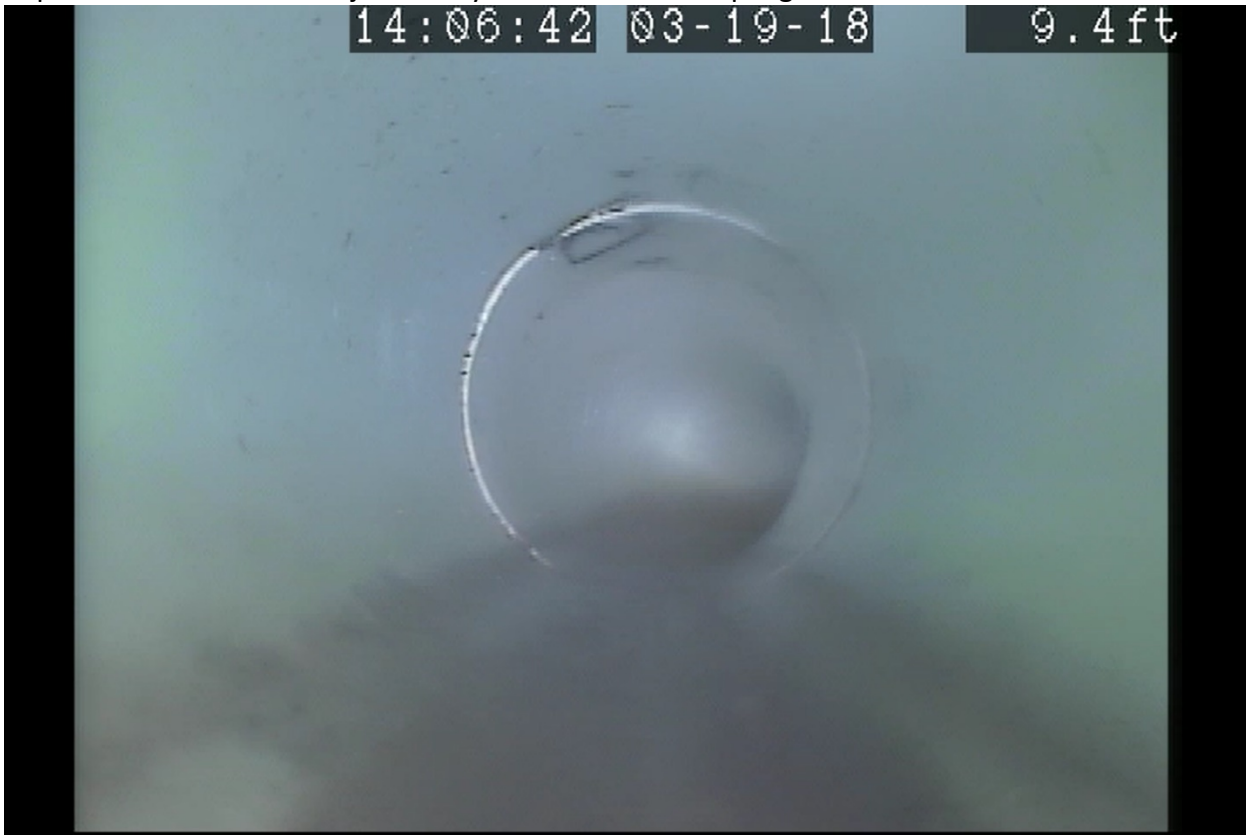
Capture #12: Clear shot of joint likely where flexible coupling to stub exists
