Subject: Consider Approval of Shared Costs with Developer for Force Main Break at Cantova Lift Station

and Requested Relocation of Line

Conflict Between New Murieta Gardens Gravity Sewer Main and Existing Force

Main Near the Cantova Lift Station

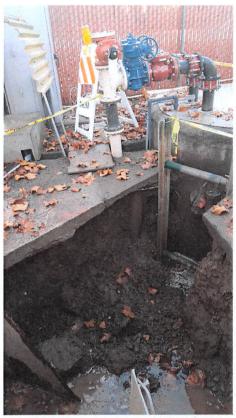
Photo 1: Trench excavation at force main break, illustrating sloughing of trench under existing AC, dated 12/17/18.

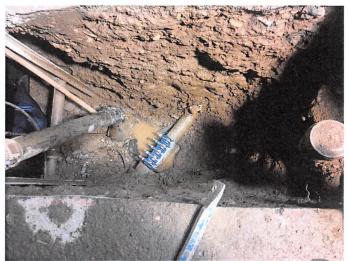
Photo 4: Temporary repair at break dated 12/12/18.

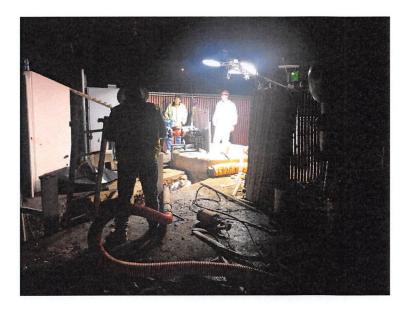
Photo 5: Site when force main was broken dated 12/12/18.
