RANCHO MURIETA COMMUNITY SERVICES DISTRICT

IMPROVEMENTS COMMITTEE

Regular Meeting
August 6, 2019 at 8:00 a.m.

Date: August 1, 2019
To: Improvements Committee
From: Paul Siebensohn, Director of Field Operations
Subject: Review of South Sewer & Storm-line inspections

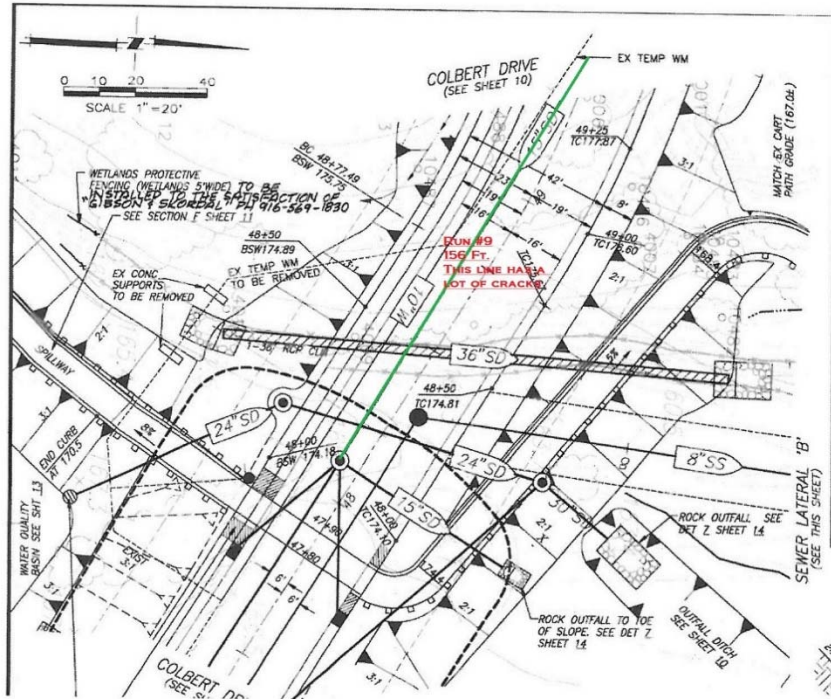
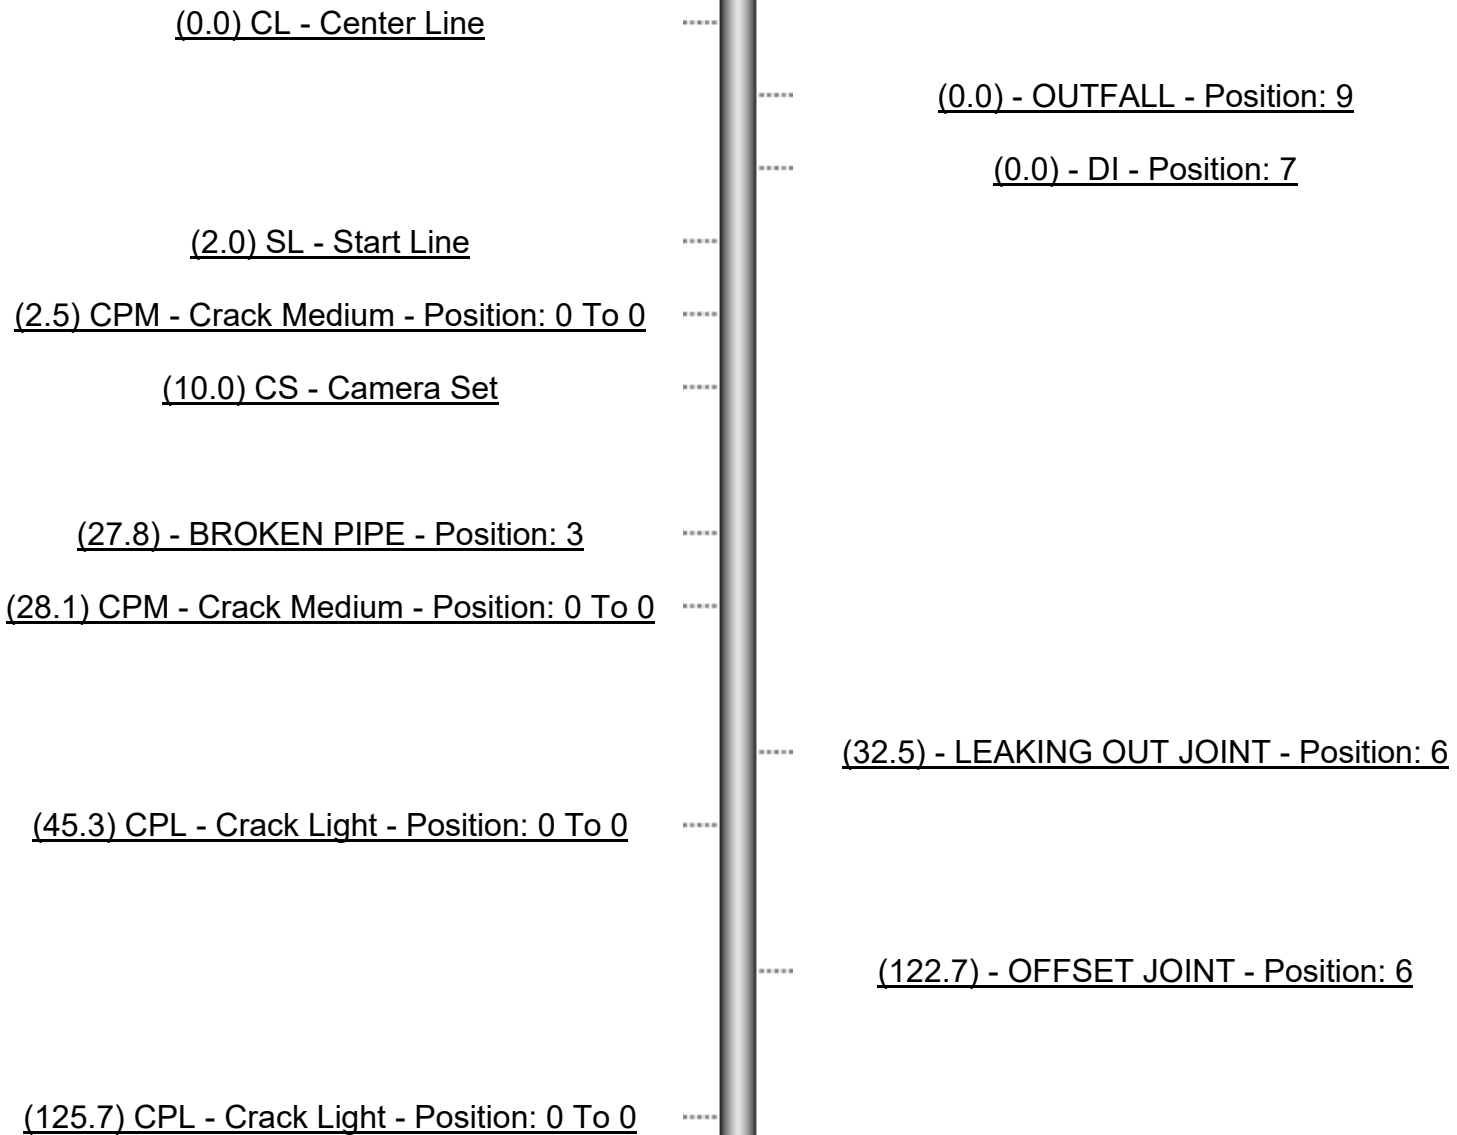
Problems found in Run #9

Large cracks in pipe at 2.5 Ft, 28.1 Ft, 151.2 Ft, 152.8 Ft

Small cracks in pipe at 125.7 Ft, 134.2 Ft.

Hole in pipe at 27.8 Ft

Leak in pipe at 32.5 Ft, water is running out of pipe joint

(134.2) CPL - Crack Light - Position: 0 To 0

(137.8) - OFFSET JOINT - Position: 6

(151.2) CPM - Crack Medium - Position: 0 To 0

(152.8) CPM - Crack Medium - Position: 0 To 0

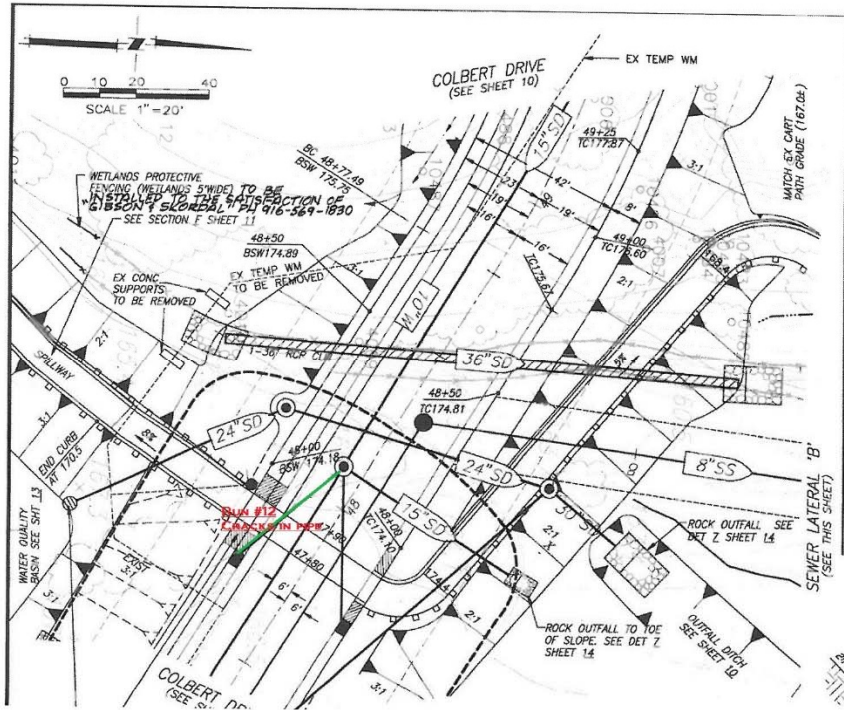
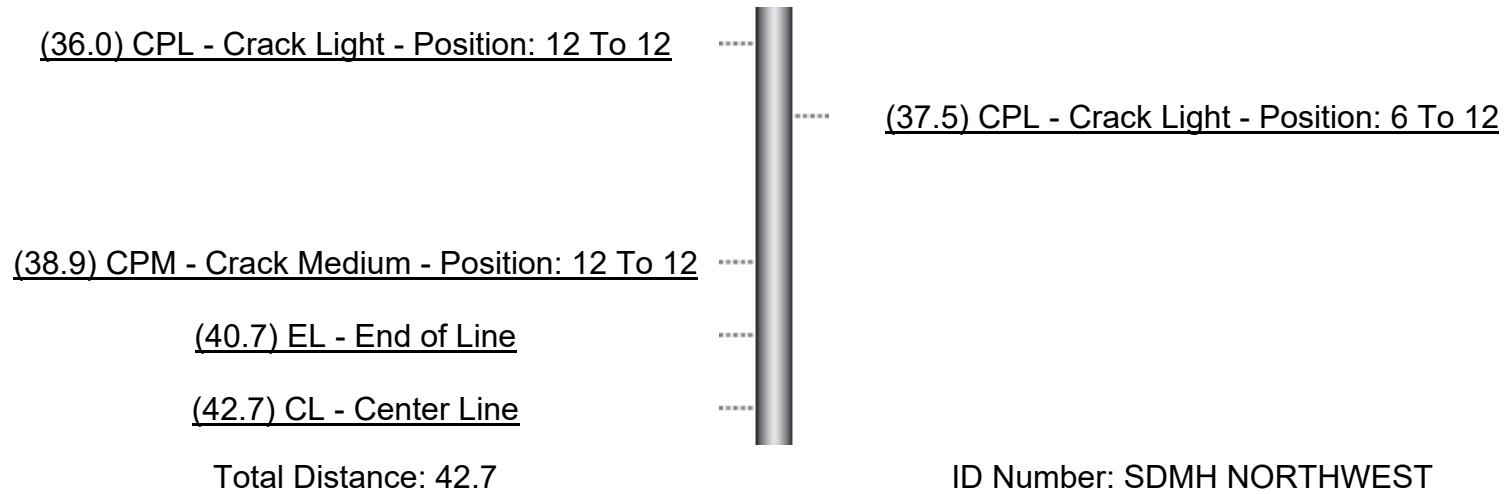
Problems found in Run #12

Cracks found in several places in pipe

- (0.0) CL - Center Line
- (1.0) SL - Start Line
- (10.0) CS - Camera Set
- (12.0) - x
- (14.1) CPL - Crack Light - Position: 12 To 12
- (21.1) CPL - Crack Light - Position: 12 To 12
- (29.0) CPL - Crack Light - Position: 12 To 12

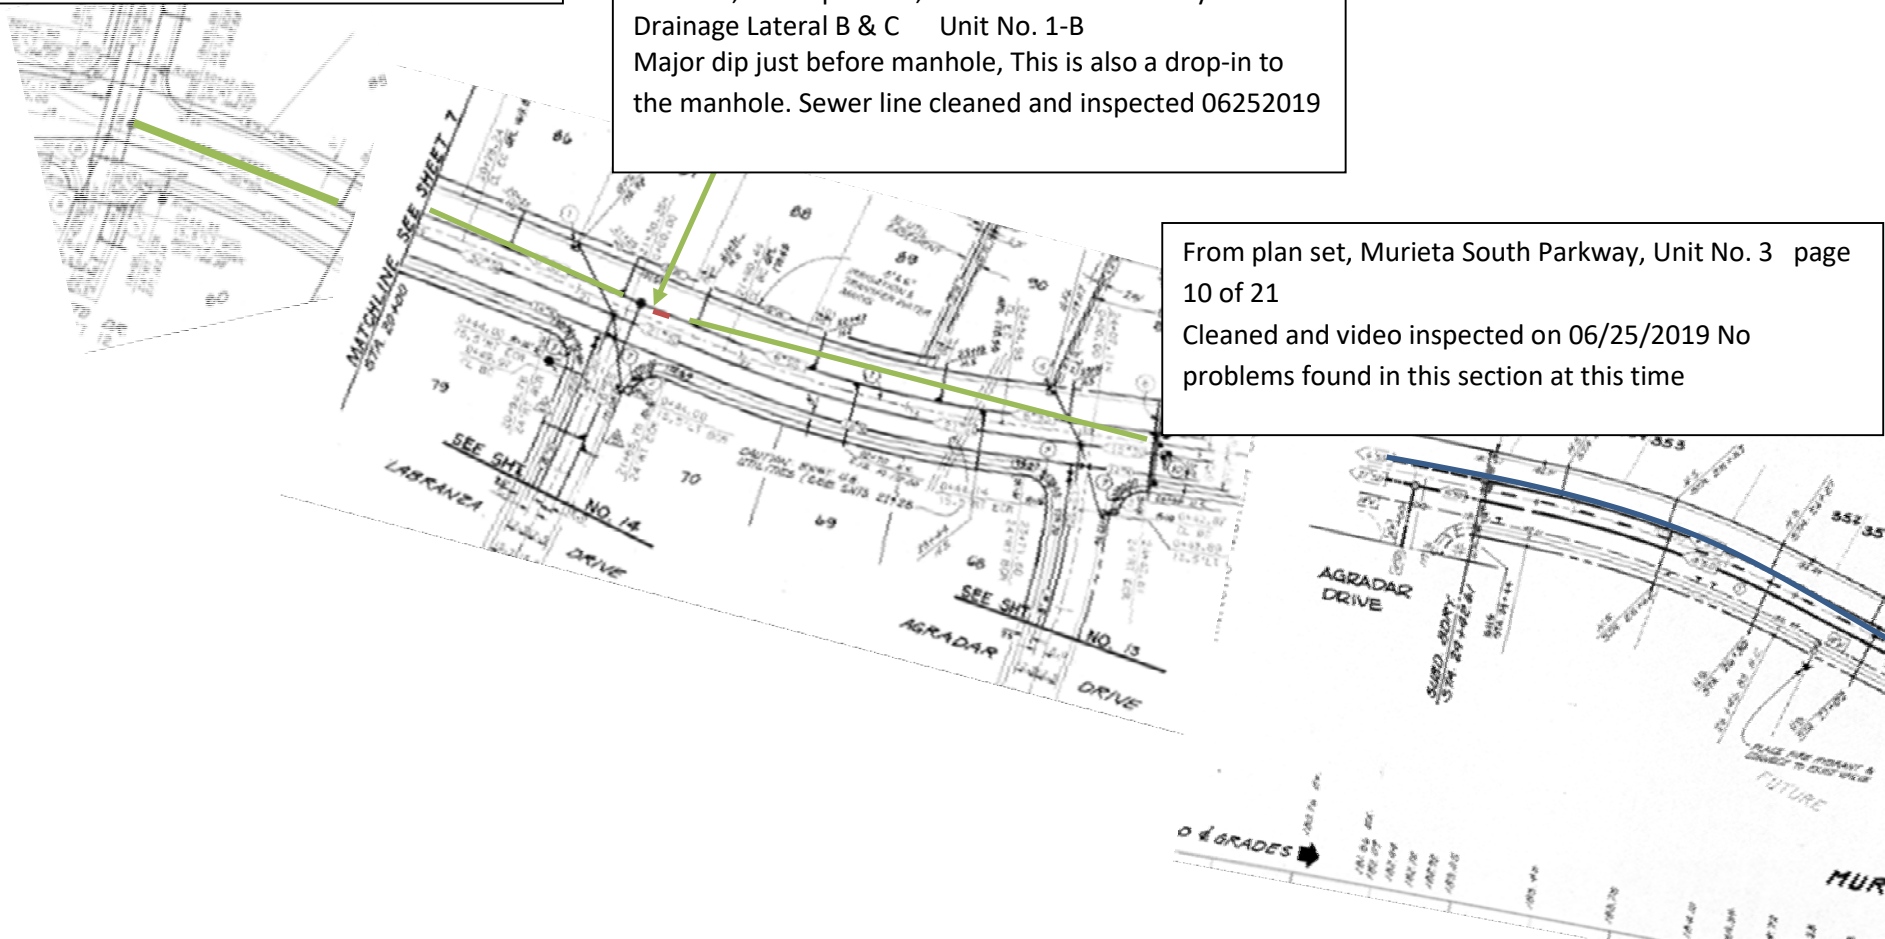
Problems found in Run #21

Dip in sewer main just before manhole

This dip holds paper back then pushes through to the drop in and has the potential to plug downstream sewer main.

This is a problem that started to be noticed in December 2018 with two sewer overflows. Staff has been following up since with inspections and repeated cleaning.

Run #21, From plan set, Murieta South Parkway & Drainage Lateral B & C Unit No. 1-B
Major dip just before manhole, This is also a drop-in to the manhole. Sewer line cleaned and inspected 06252019

Staff has been doing what they can so far to remedy issues discovered, removing and treating roots in lines. The sag in the sewer pipeline in run 21 will most likely need a project put together for it to go out to bid for a qualified contractor to repair.
