RANCHO MURIETA COMMUNITY SERVICES DISTRICT

Cosumnes River Sanitary Survey

Update - December 2011

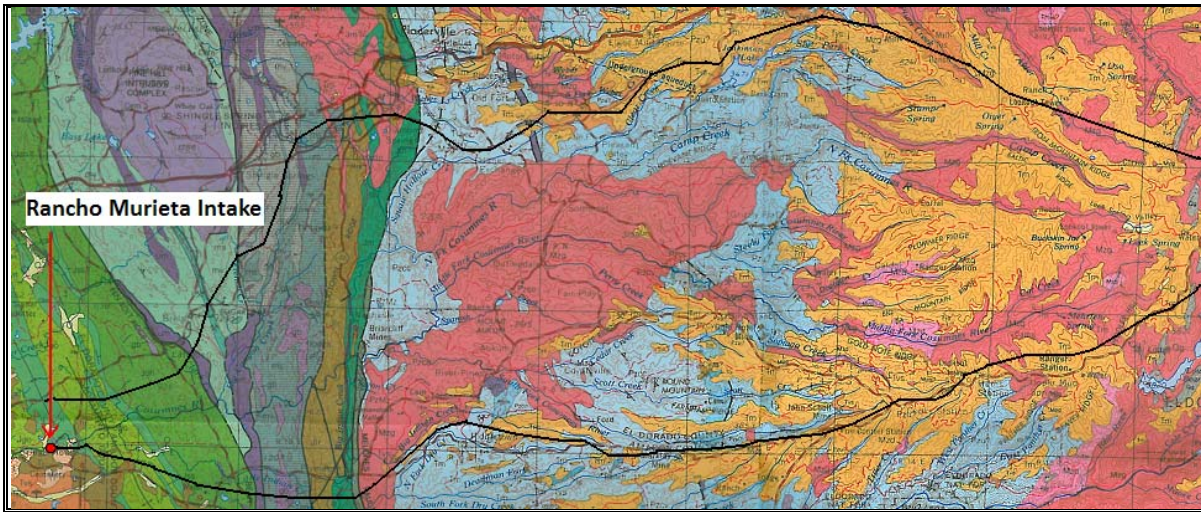
Figure 2 - Geologic Map of Cosumnes Watershed Upstream from Rancho Murieta

Geologic Map of the Sacramento Quadrangle showing Cosumnes River watershed upstream from District intake at Granlees North Dam.

Since this watershed encompasses such a wide range, its geologic morphology is quite diverse. At its eastern limits it is comprised of a combination of the Merhten, Mesozoic granitic rock, and Calaveras Complex rock formations. As it slopes west, it passes through bands of volcanic and metavolcanic rock formations, Copper Hill Volcanics, Gopher Ridge Volcanics, and Jurassic metavolcanic rocks. Soils of the watershed are predominately Auburn-Argonaut and Serpentine-Delpiedra associations. These soils are characterized as well to excessively drained silt and gravelly loams derived from weathered basic and metasedimentary rocks.

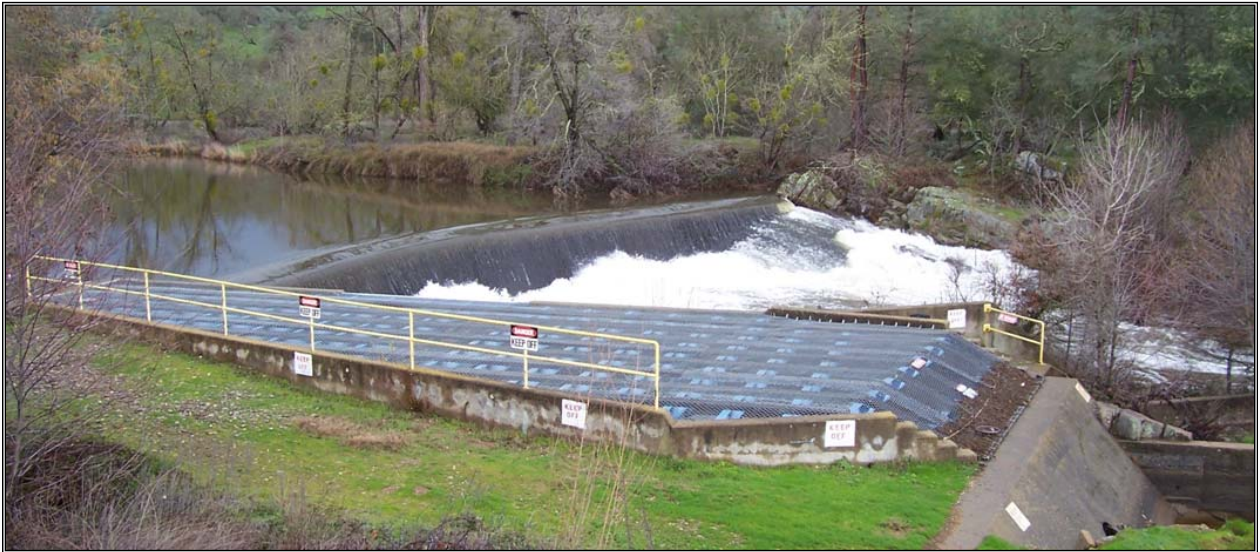
The Granlees North Dam and Pump Station are equipped with two 125 HP pumps (minor capacity) and three 500 HP pumps (major capacity). Maximum diversion capacity is 6 cfs (2,693 gpm) for each 125 HP pump and 15 cfs (6,885 gpm) for the 500 HP units. Typical diversions utilize the minor capacity pumps. However, if the river flows have not been sufficient until later in the diversion season and the District needs to divert its allocation of water, the major capacity pumps are used. The forebay diverts Cosumnes River water through a collection system of 12 screening elements consisting of 3/32" mesh intake screens, cleaned annually by staff prior to its diversion season, as well as being backflushed by an air-purge system when in operation. Although the electrical power facilities are sized to operate the three 500 hp units at once, hydraulic capacities do not allow operation of all five pumps simultaneously. A maximum of three major capacity pumps can be used at one time. Flow rates diverted by the pump station are recorded by a totalizer on the discharge piping.

Granlees Diversion structure on North side of Cosumnes River in Rancho Murieta

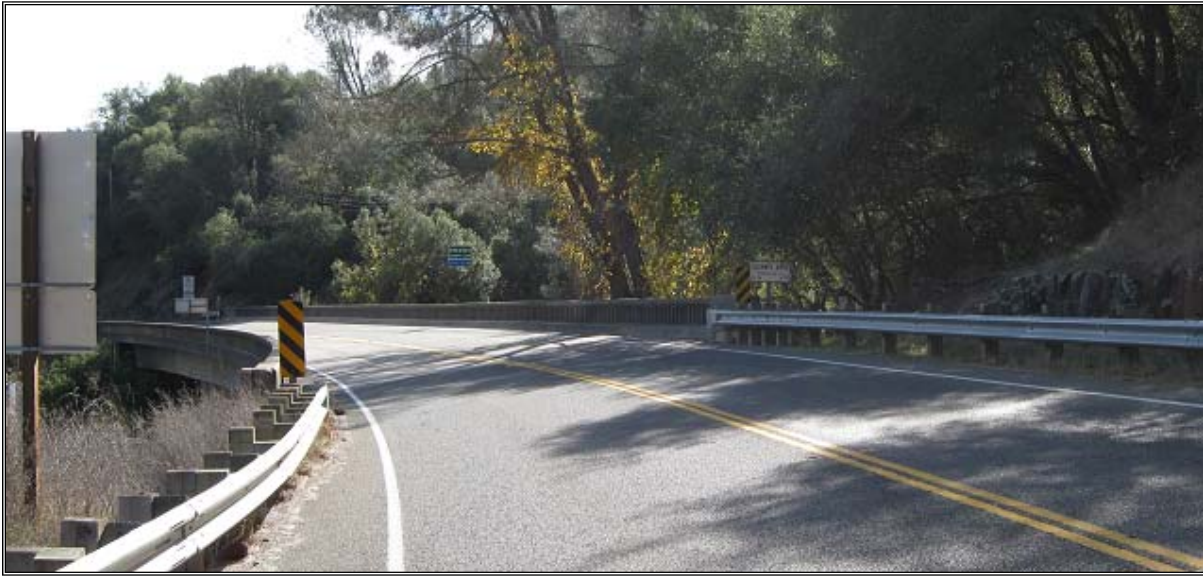
Highway 49 crossing Cosumnes River at Amador & Eldorado county line

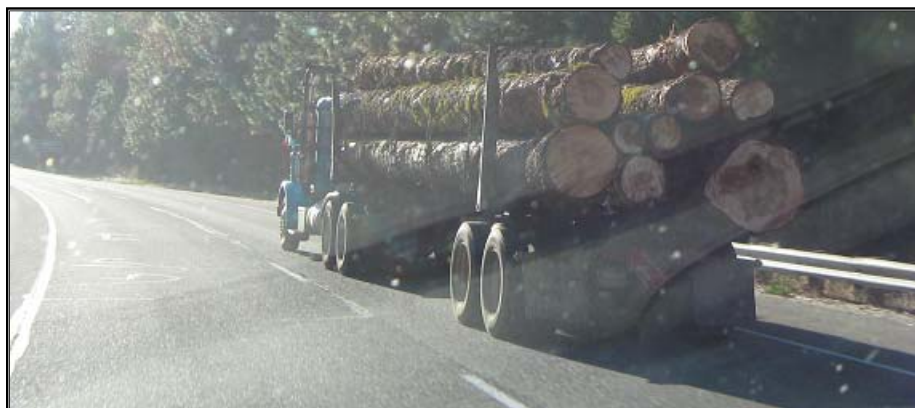
While I was out visually assessing the watershed on the North Fork of the Cosumnes, eight logging trucks hauling timber were observed within a four hour time frame. I have also observed a lot of logging trucks passing by the District office between spring and fall over the past three (3) years. These observations led me to believe that there could be the potential for considerable erosion within our watershed. However, upon investigating the various forks of

Sierra Pacific logging truck carrying timber from the Cosumnes Watershed

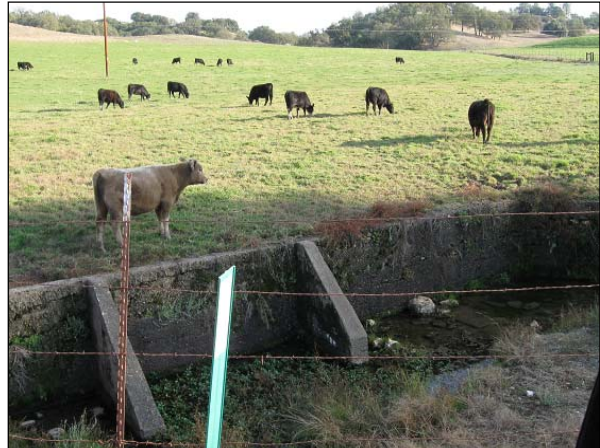
On private lands most of the large scale grazing is located near to Crawford Ditch area and in the Clear Creek watershed. These grazing areas support between 300-400 head of cattle.

Cattle Ranch adjacent to Michigan Bar Gauging Station
